A Conservation Study of Djin Block No. 9 in Petra
Talal Akasheh*, May Shaer, Bilal Khrisat, Maram Naes, Rwan Sarayrah
Queen Rania Institute of Tourism and Heritage
The Hashemite University – Zarqa Jordan

Abstract:

The Djin Block No. 9

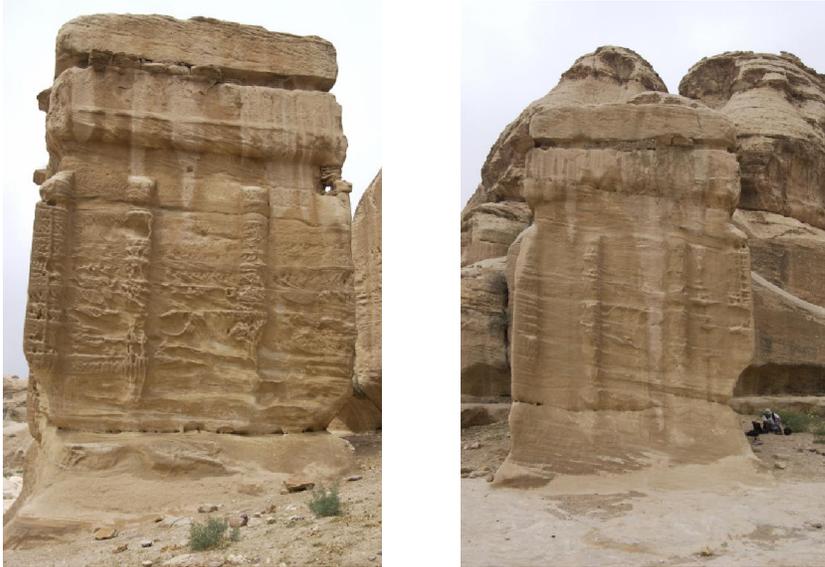
Figure 1: East side of Djin Block 9. Right represents the Southern side

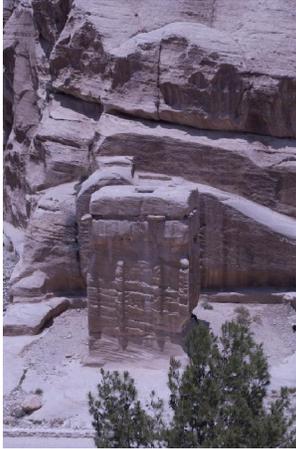
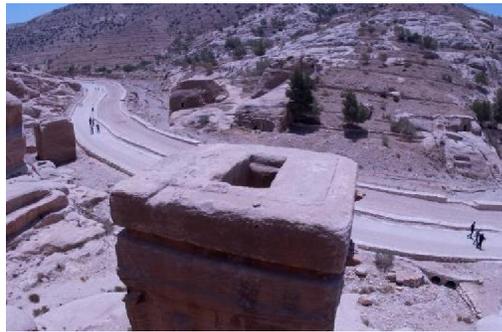
Figure 2(a) Grave at rooftop with sandstone ridge behind. The ridge has a carved channel that used to carry a clay pipe behind the monuments. (b) On the right a closer view of the rooftop shows the surface that was carved into a grave.

- 1- The Roof: In general the roof is in good shape. However some scaling and exfoliation is observed. Edges are rounded thus allowing for easy water runoff along the façade faces. The edges of the tomb are pitted, and a recess to hold the tomb cover is heavily rounded. Since the tomb is open, it is liable to collect water during rainfall thus establishing long contact times between water and stone, and causing more water impregnation into the rock. The outcome is of course more salt dissolution and re-deposition of salts on the surfaces.

- 2- Salt removal may be done using a poultice of kaolinite, clay and cellulose with water (2:1:1:2).
- 3- The grave on top should be closed to prevent rainwater storage during winter time and to prevent any prolonged contact with water. This is probably the main reason for the mortar damage at the top of the monument.

- 4- The rooftop should have adequate water drainage as water flow down the facades is detrimental. Water repellants and consolidants for the roof could be very useful.

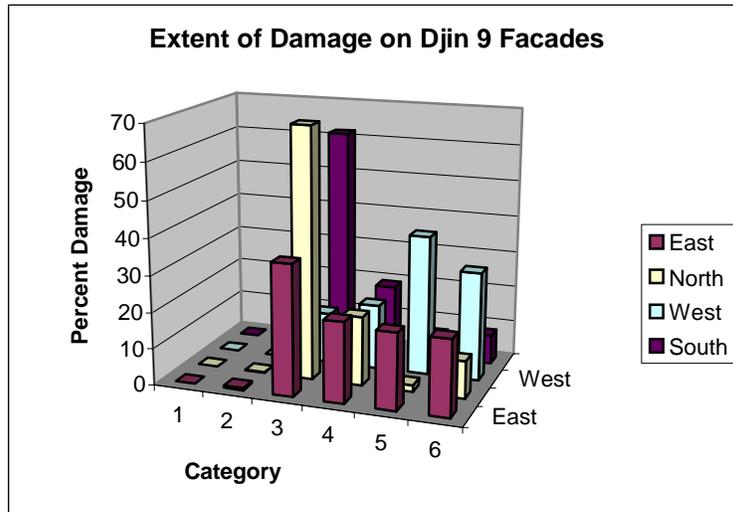
Table 1 and Figure 4: Damage extent due to weathering on the four sides of the Djin Block No. 9

From the chart it is clear that the damage extent follows the sequence: South>East>North>West. The difference between North and West being slight. To understand this it must be mentioned that the real orientation of the facades is actually about twenty degrees off. In other words the east facade is twenty degrees off East. The Western side of the monument receives the highest solar radiation. A study conducted by Tom Paradise (2005) shows that for Djin block number 5, sun exposure is an important factor in determining damage extent. The higher the exposure the more damage that occurs. In Djin number 9, the North side is totally hidden from sunlight during the whole day (by the small cliff behind the monument). In fact the surface of the northern facade was seen to be wet during April and June 2005, long after the rainy season was over. The exposure to hard sun results in evaporation of water in the rock pores thus causing salt

deposition with more dramatic results than for the unexposed facades. Temperature cycles and temperature variations during the day-night cycles are also more pronounced in exposed surfaces. In a private communication the actual temperature measurements performed by Heinrichs and Fitzner indicate that the Western side has the highest temperatures on the stone surface. Thus according to Paradise this side should exhibit the highest damage extent, thus contradicting the present findings. The true reason for the extent of damage can be sought in the higher wind effects that are hitting the Southern and Eastern sides. Thus, alveolar weathering due to eolian effects, intensified by water seems to be a very important factor. Here, water down flow, and capillary rise, are the main mechanisms of weathering, rather than sun exposure.

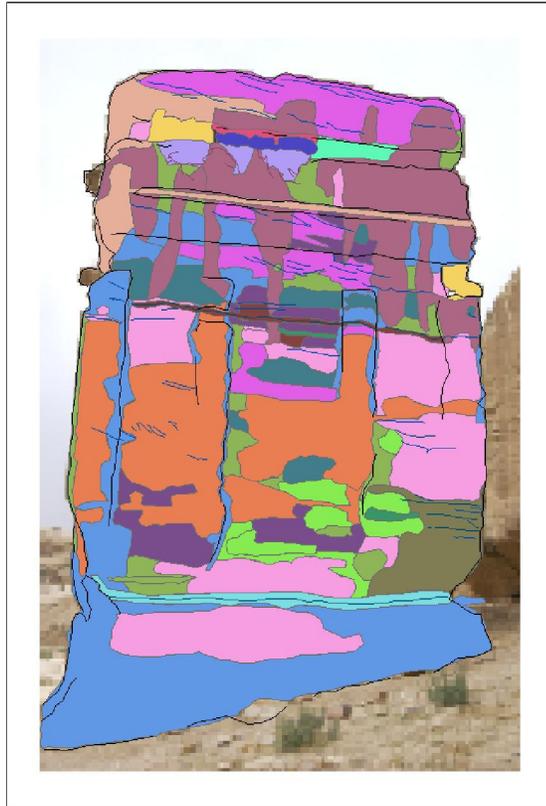
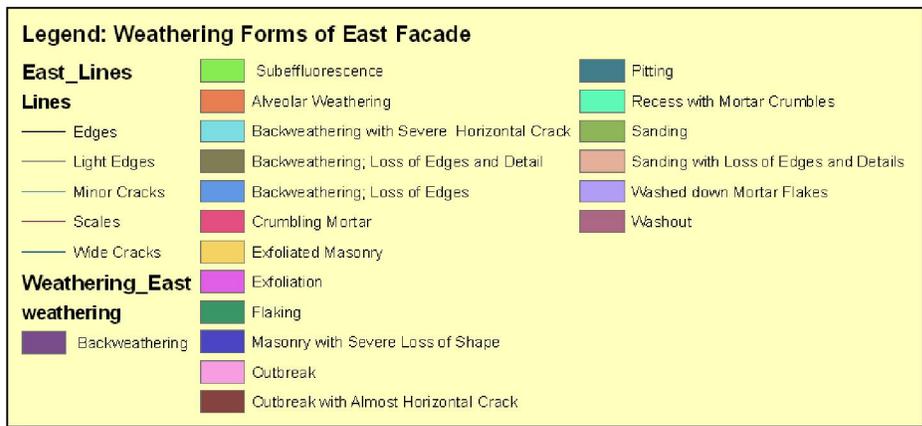
The following figure on the next page shows the weathering forms that have been observed on the Eastern and Southern sides of the Block. Alveolar weathering seems to hit the highest surface area amongst all weathering forms if one ignores backweathering and outbreaks where the loss of material does have an obvious mechanism of deterioration. It must be stated that all factors of weathering operate jointly on the surface and it would not be possible to always identify which weathering form is predominant on a particular region or spot on the façade.

Figure 5: Mapping of Weathering forms for the Eastern Facade

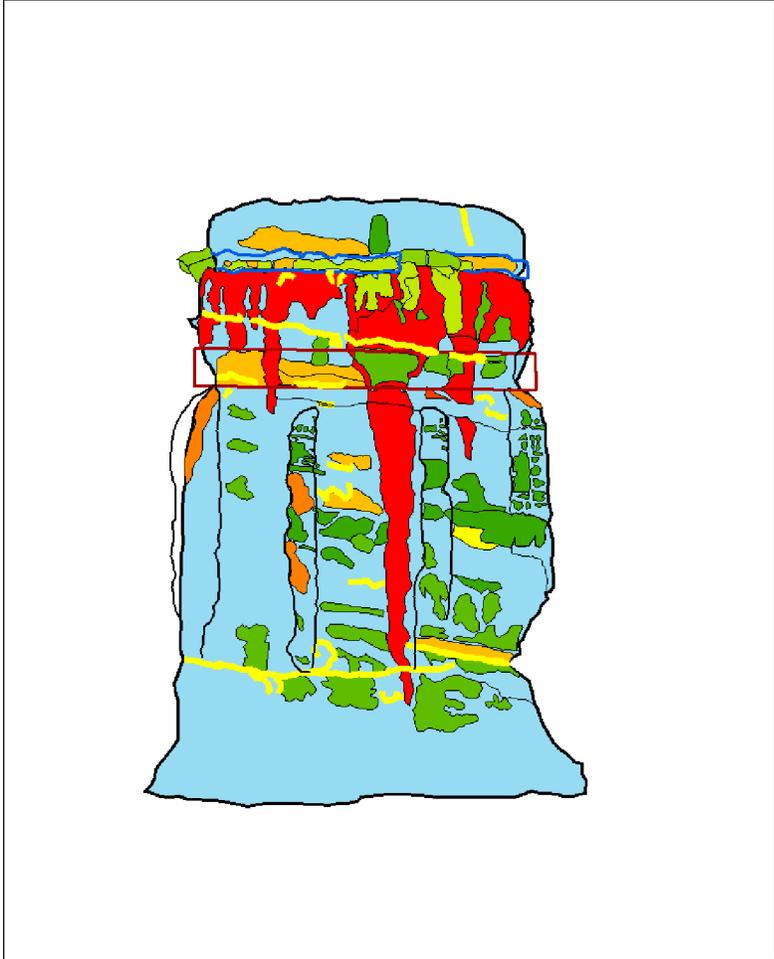
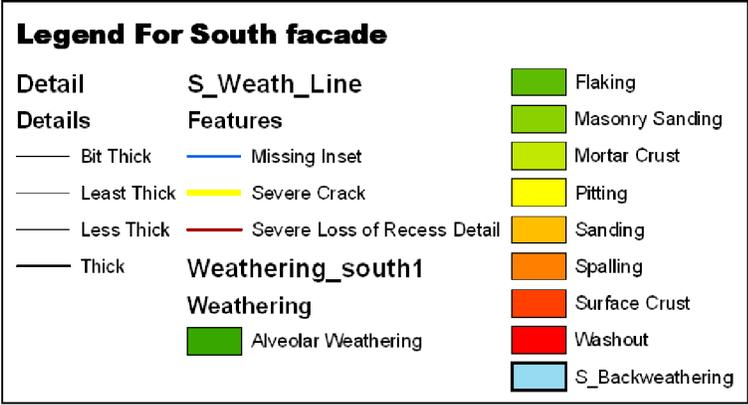
Figure 6: Weathering Forms on the Southern Facade

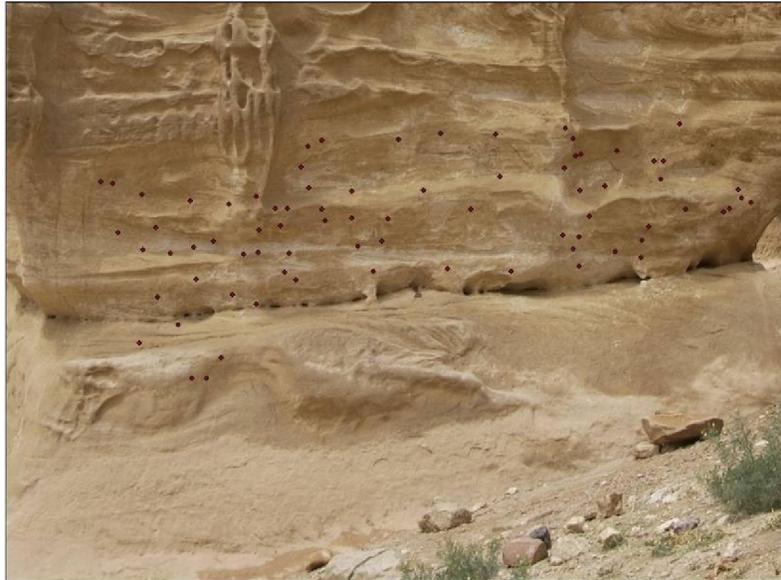
Figure 7: Distribution of XRF testing points on the lower part of the Eastern Façade

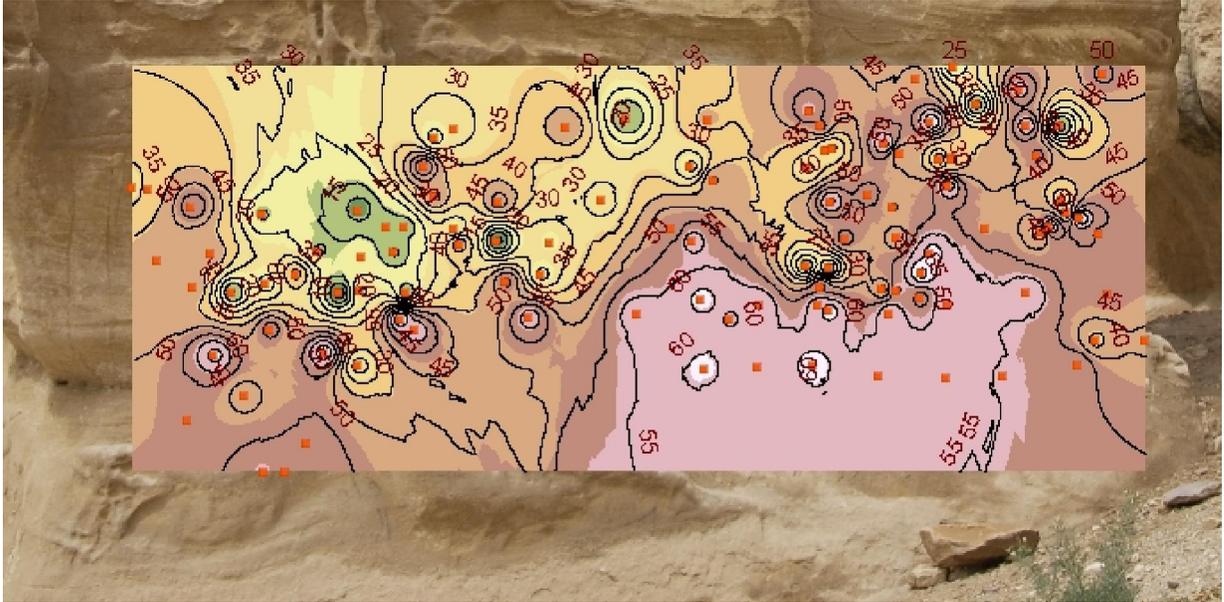
The XRF tests were analyzed by a semi-quantitative analysis of the data using home made elemental standards. About 130 points were measured and the data for the elements or their ratios were entered into a GIS and the image of the monument was rectified so that the exact location of the points could be located on it (as in the figure above). Using spatial analysis techniques, the elemental distribution of the points was transformed into a grid distribution, from which contour lines for each element could be drawn. This is probably the first time ever such an approach is used where non destructive techniques are used in situ and spatial analysis is utilized. The value of such a method is that it shows promise of following salt migration and salt concentration without the need for destructive sampling. Furthermore, there is a very good chance that the elemental grids and contours or those derived from elemental pair ratios, could be correlated with the weathering forms or extent of damage. However, due to budget limitations and time constraints, and as shown in the points distribution diagram, there is need for maybe twice the number of points to get more significant correlations than is apparent currently. This work is currently in progress. The grids and contours of some elements are shown below to illustrate the results. For Calcium the highest concentrations are seen to occur at the bottom of the monument, possibly due to down flow of salts by washdown during the rainy season as well as capillary rise due to water pools.

Figure 8: Calcium Grid Distribution and Contours (Contour labels are in %)

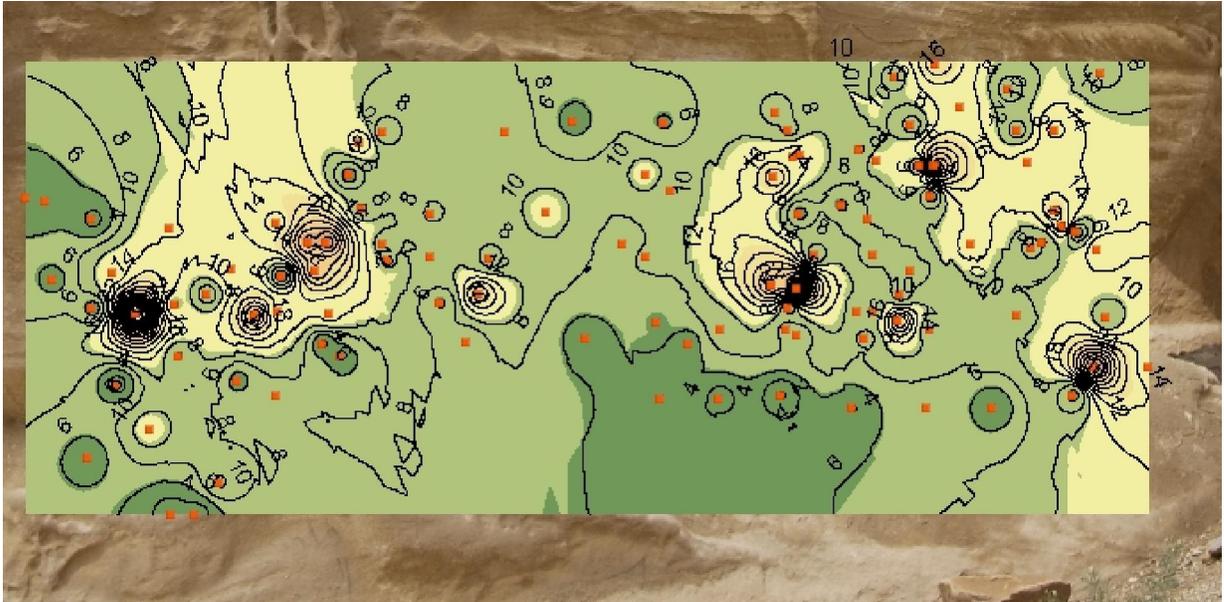
Figure 9: Chlorine Distribution

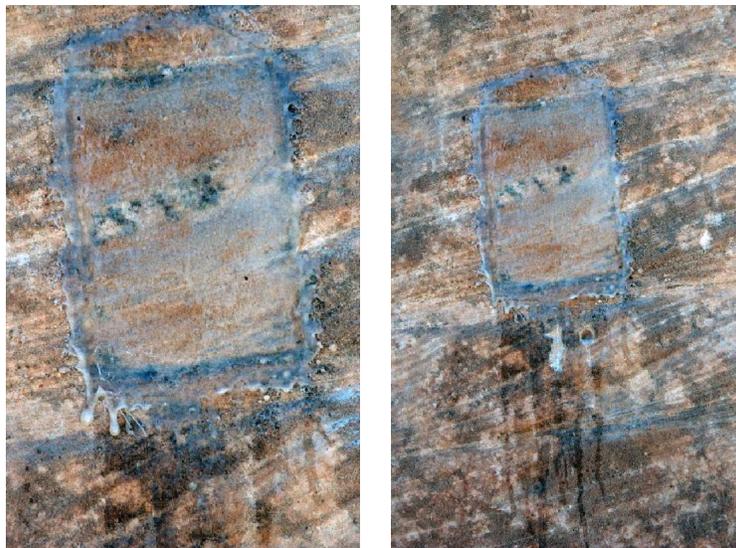
Figure 10: Application of Palaroid B72 in the field

The results in the figures above show that in time the wet impression that the surface exhibits, clears up in time in the case of the application of Funcosils and Tetraethoxy Silane. Esthetically Palaroid is unacceptable. Furthermore the fact that Palaroid B72 is highly water repellent makes it a very poor candidate because of the possibility of water accumulation behind the treated surface. This can have detrimental effects on the monuments and its façade. The surfaces are consolidated in all cases, although the extent was not determined because it is too early to judge and it is too early to take core samples for laboratory testing of the application. It is also expected that in the case of the silicic acid esters the stain will disappear. This is the observation made during the consolidation of monument 825 by these materials. It remains to be said that a better product has been utilized on monument 825. This is Funcosil 510, which seems to be a better consolidant.

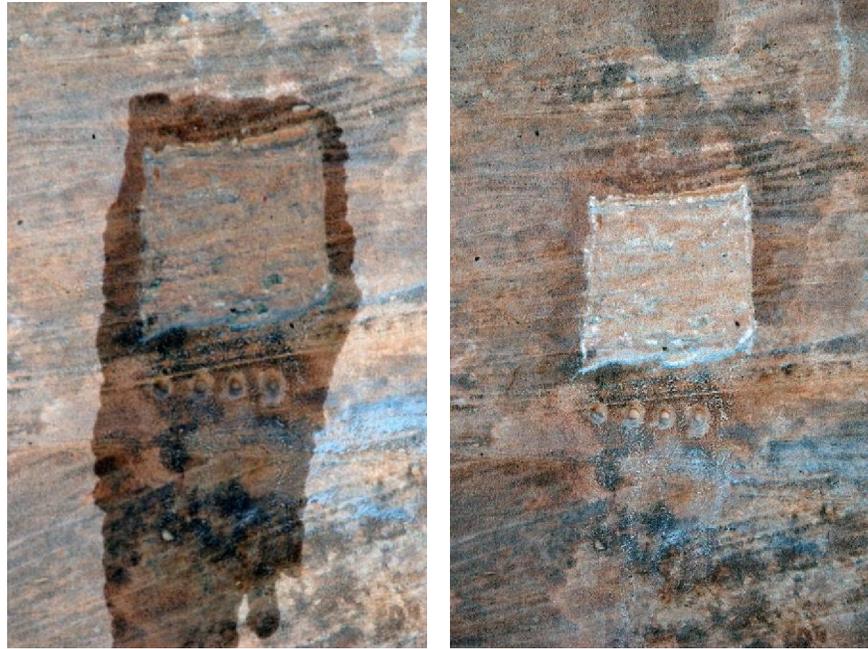
Figure 11: Application of Funcosil 100 in the Field

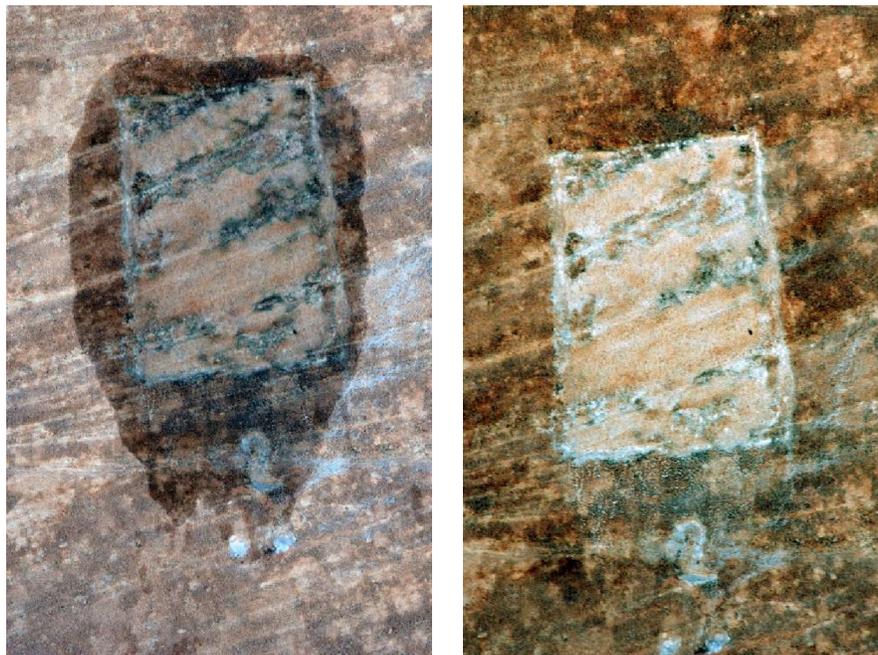
Figure 12: Application of Funcosil 300 in the Field

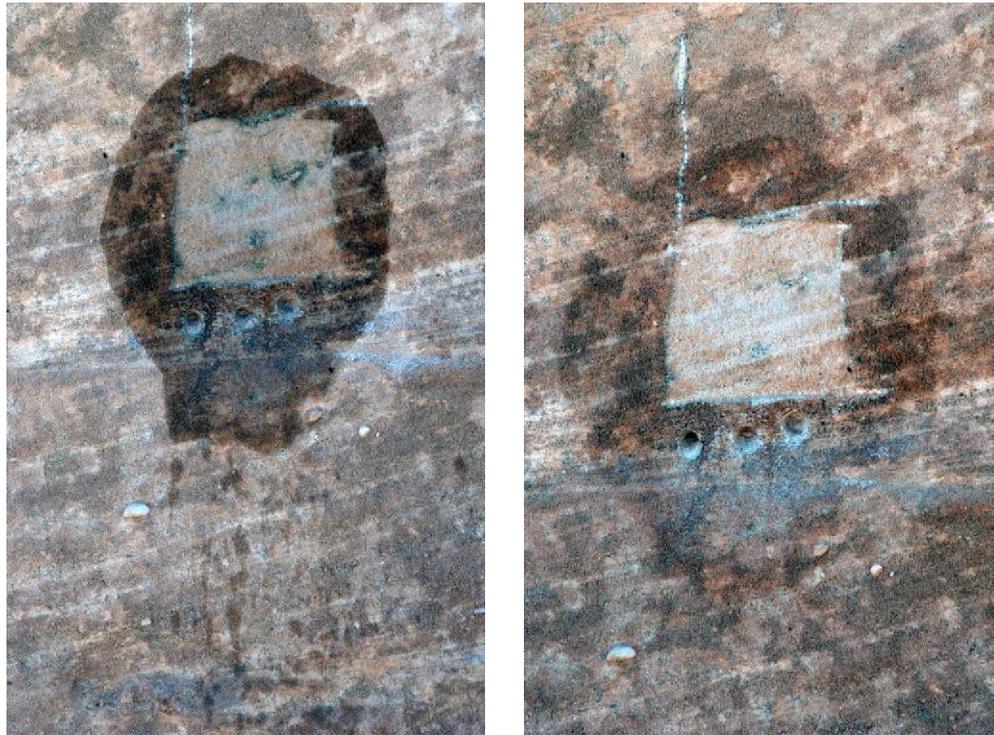
Application of Tetraethoxy Silane in the Field

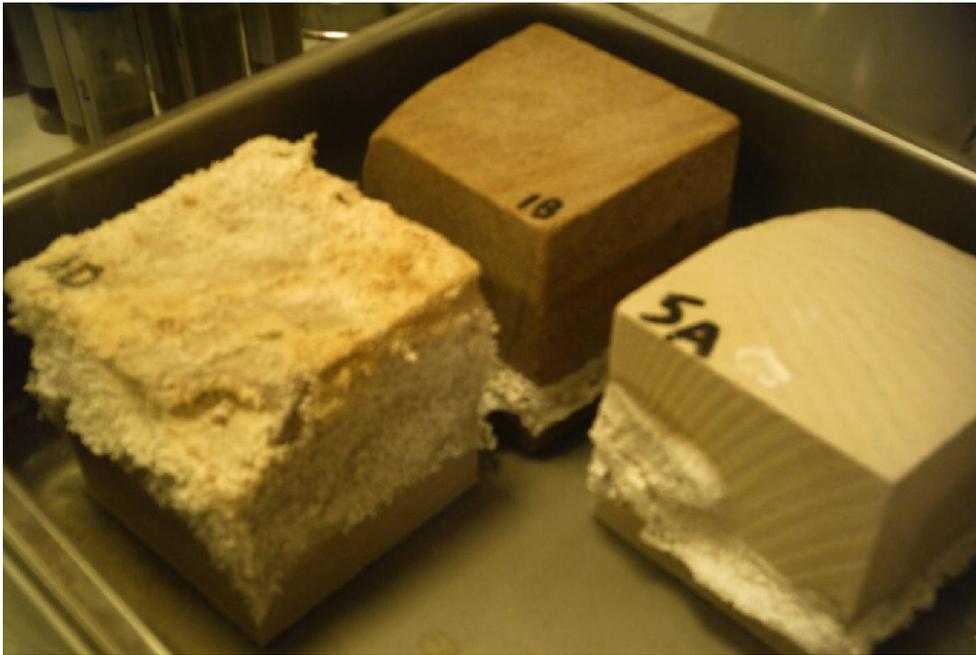
The salt tests were carried out on 10x10x10 cm stone cubes. These were immersed to a height of two centimeters of a 5% sodium sulphate solution and left for up to 20 days while keeping the liquid constant by replenishing any losses. The figure below show four samples. One was not treated to be used as a reference while the other three were each treated by one of the silicic acid esters respectively. Obviously the salt rise was effectively hindered for a period of 20 days by the adhesives, while the untreated sample was filled with salt to its top even within five days of application.

Figure 15: The salt test after 20 days. 1D on the left was untreated. 5A was treated with funcosil100, while 1B was treated with Funcosil 300. The latter seems to yield better protection against salt rise. In the following pictures the stone samples are also shown individually and from the top.

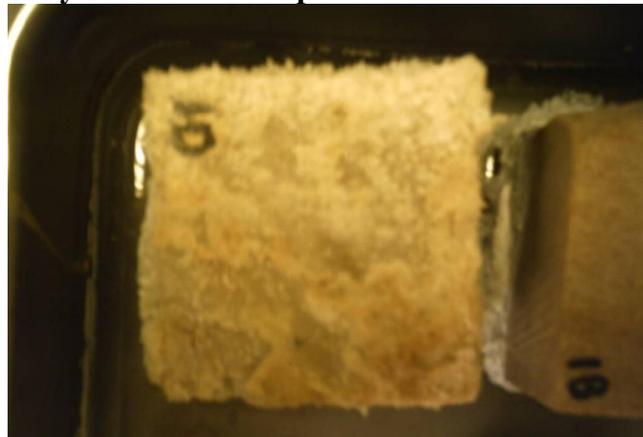
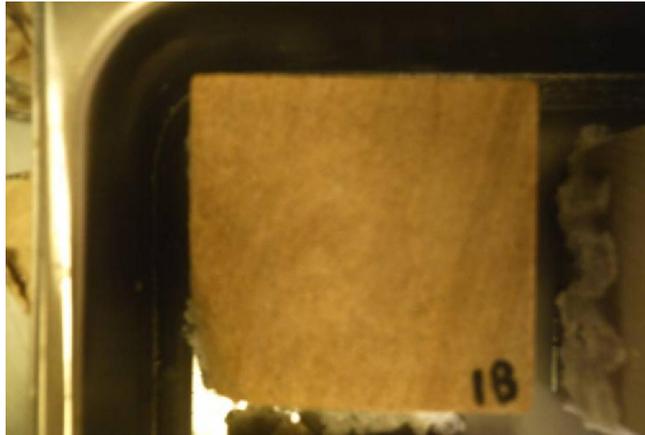
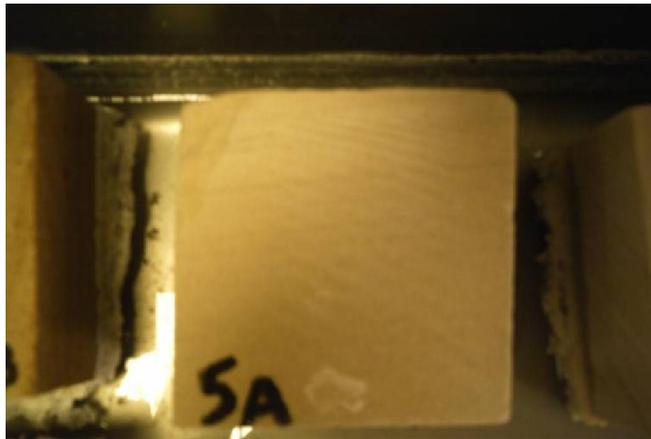
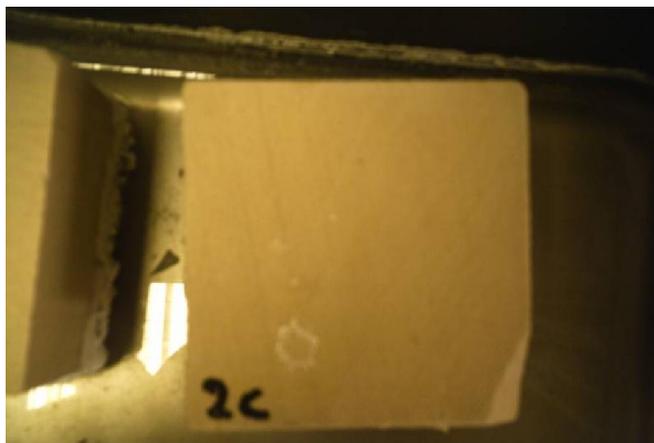
Figure 16: Stone samples and the salt test shown individually (2c is for tetraethoxy silane)
