A Conservation Study of Djin Block No. 9 in Petra
Talal Akasheh*, May Shaer, Bilal Khrisat, Maram Naes, Rwan Sarayrah
Queen Rania Institute of Tourism and Heritage
The Hashemite University – Zarqa Jordan

Abstract:

The Djin Block No. 9

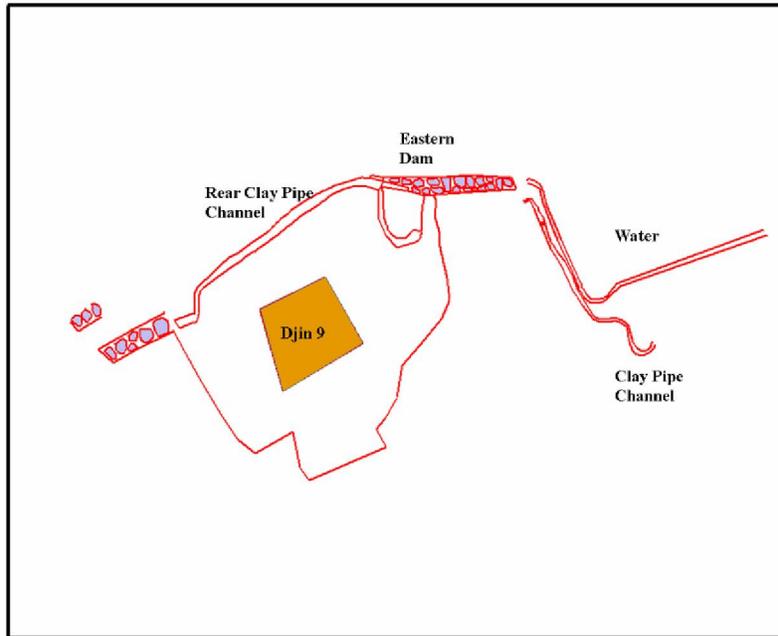
At the bottom of the Northern sandstone ridge, a channel that has been carved to carry clay water piping to the city of Petra exists. The water management around the Djin Block is extensive and its damage may have contributed to weathering of the monument.

Figure 3: Water Management Layout around the Djin Block

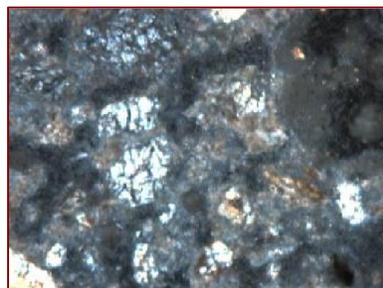
Figure 14: Polarizing microscopy of Stone Sample

All samples were studied under the polarizing microscope and a typical result is shown in Figure 14 where the presence of quartz arenite was confirmed.
